## Increasing the Sensitivity of the Dipole Method: A Case Study

Abigail Gilson-Beck, P.E.,<sup>1</sup>  
Richard Thiel, P.E.,<sup>2</sup>

### ABSTRACT

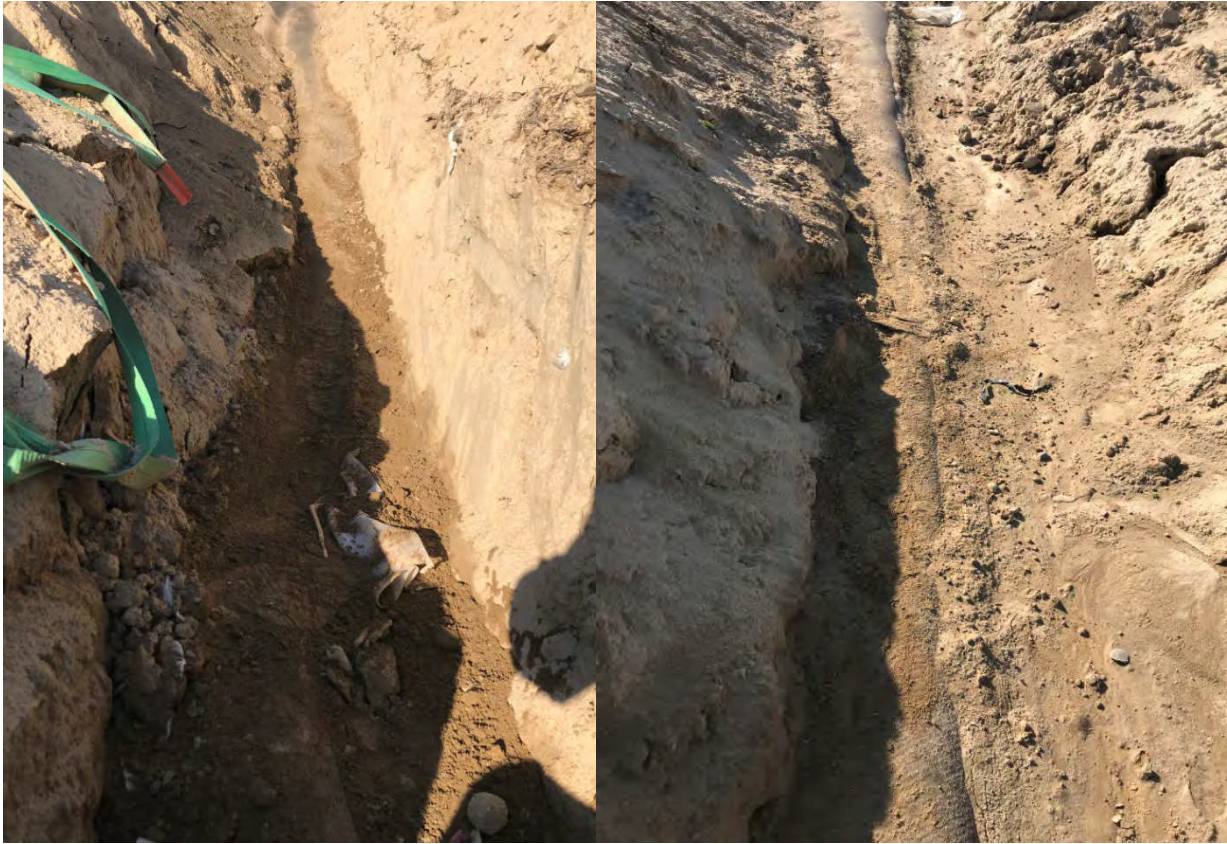
**Figure 1. Perimeter Isolation Issue at Access Road Location Causing Primary Survey Portion 3 Sensitivity Issues Before Cleaning (Left) and After Cleaning (Right).**

During each survey, the relevant upper soil layer being surveyed (i.e. the 0.3m separation layer for the secondary liner system, and the 0.6m operations layer for the primary liner system) was stopped short of connecting with the perimeter of the new cell to provide electrical isolation. On three sides of the rectangular cell the perimeter consisted of a permanent anchor trench, and on one side the perimeter consisted of a tie-in to a previous cell. At the base of the unconnected gap between the new soil layers and the other side of the perimeter one could visibly see the exposed geocomposite drainage layer over the geomembrane. Electrical isolation was maintained by keeping the exposed geocomposite and geomembrane in this gap relatively clean and dry (Figure 1).

The 3<sup>rd</sup> portion of the primary liner system campaign showed particularly troubling voltage readings in that both of the functionality measurements had positive values. Without the negative voltage value with the front dipole foot over the artificial leak, the artificial leak is not strongly detectable. After reviewing these results, the perimeter isolation gap was inspected and the isolation improved before beginning the testing. A location along the perimeter immediately adjacent to the location of the artificial leak exhibited a strong signal due to the isolation issues shown in Figure 1. This location was determined to be the cause of the isolation issues upon analysis of the voltage mapping. This type of perimeter isolation issue is very typical of landfill expansions. Also it is noteworthy that the silty/clayey soils comprising the upper soil layers at this site are much more electrically conductive than clean sand and gravel layers that might be used for the drainage and operations layers at other sites, and this increased conductivity exacerbates the isolation issues.

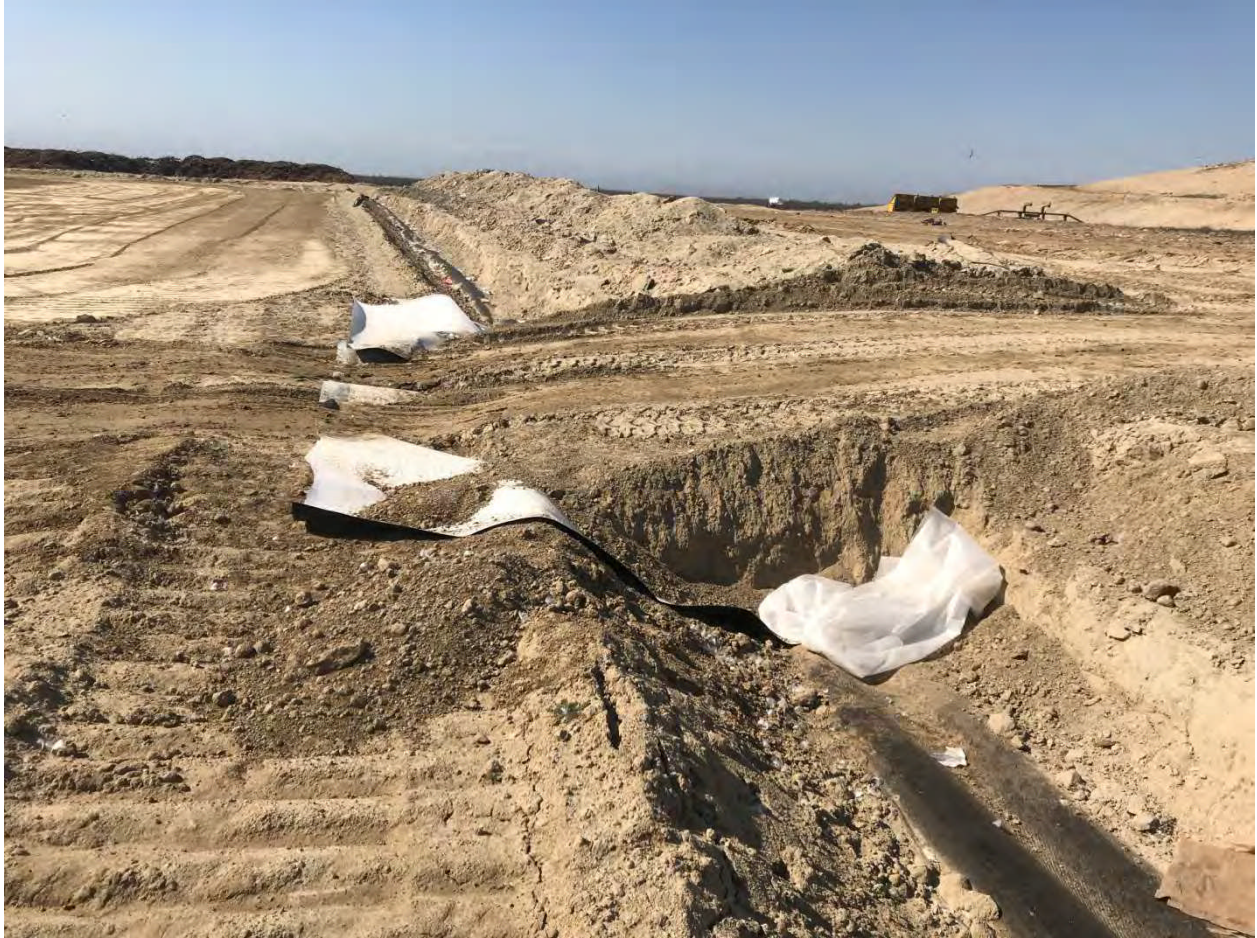
**Figure 2. Method of Electrically Isolating Access Roads**

The method of electrically isolating access roads to maintain survey area truck access for spray-irrigating the cover soil material was to use a geomembrane flap. The flap was placed across the isolation trench and extended up through the access road soils to create an exposed edge, as shown in Figure 2. Such a flap, if used, is best welded to a rubsheet, which in turn should be welded continuously all around to the containment geomembrane, so that the flap weld does not adversely affect the containment geomembrane.

The entire perimeter isolation gap was then further cleaned and all of the access roads, such as the one shown in Figure 2, were completely removed. Functionality testing was repeated without any significant improvement. The second author was the approving engineer for this project and insisted that the 1/4" artificial leak be detectable before commencing the survey. He suggested the use of a high-powered leaf blower, directed at the geocomposite, proceeding along the entire isolation gap very slowly in order to thoroughly dry out the moisture trapped by the geotextile on the underside, and it would also tend to blow out any loose soil in the gap area. The backpack leaf blower that was used is shown in use in Figure 3.

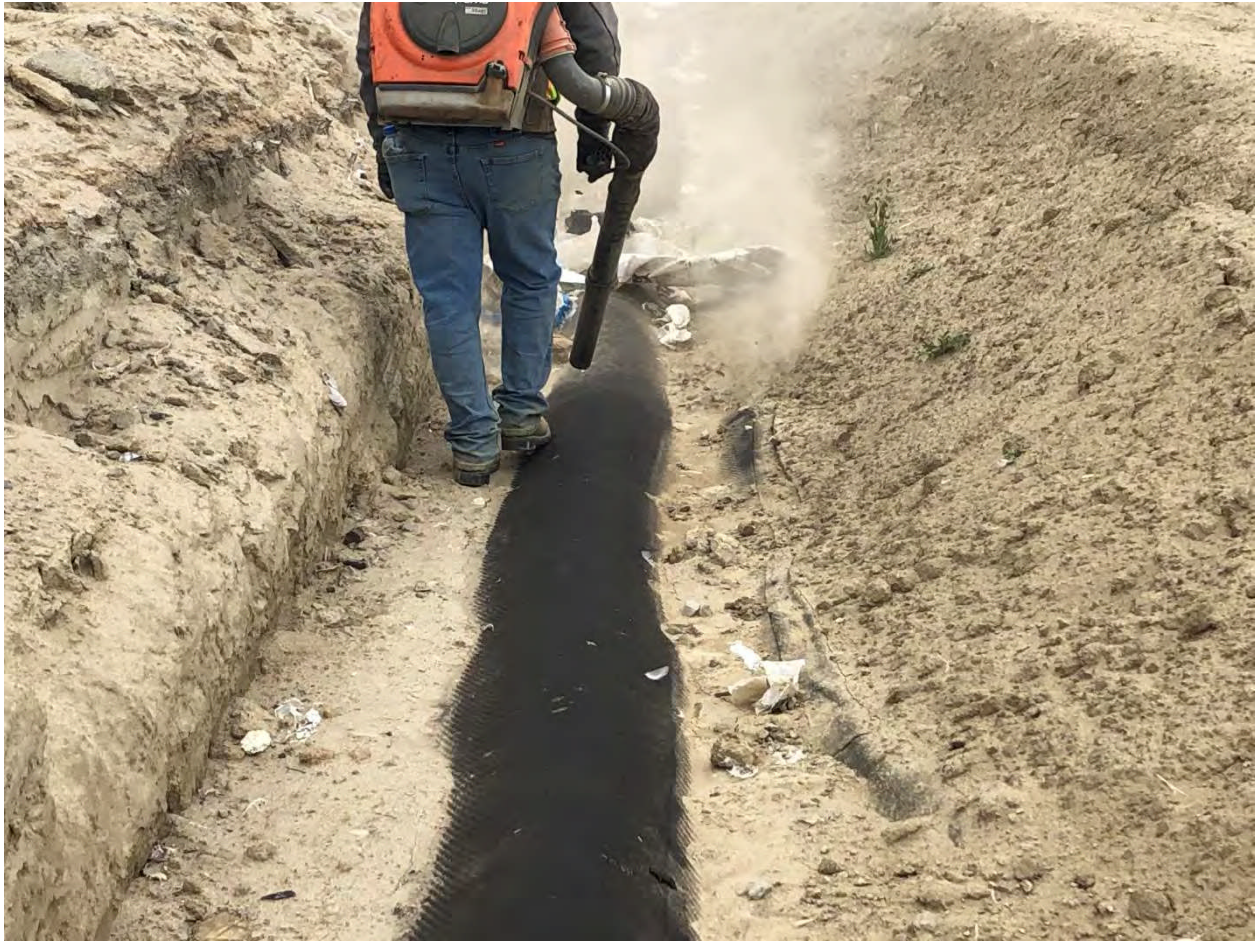
**Figure 3. Backpack Leaf Blower Used to Dry out the Geocomposite in the Perimeter Isolation Gap.**
